Re: **ADDENDUM NO. 2**

23-064.1 – Pier 84S Pile Repairs

The Port of Philadelphia PIER 84 South CONDITION SURVEY

WBCM Project No.: 20210280.02.0

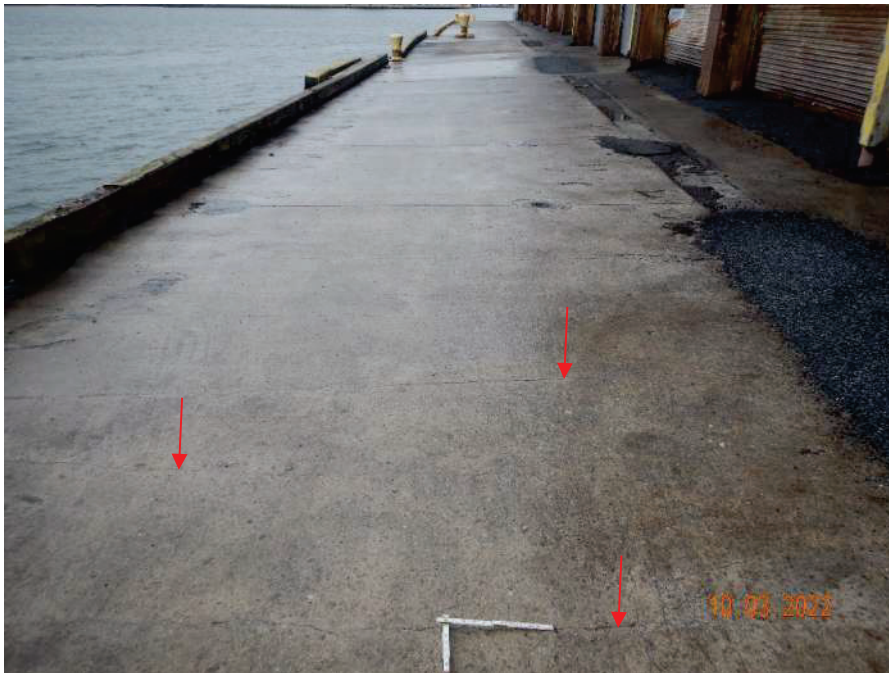
- 2.1.1 Top of Deck – Overall the Top of Deck was found to be in **Fair** condition. The exposed areas of concrete at top of deck along the North Apron typically exhibit transverse cracking up to 1/8-inch wide and spalling up to 1-inch deep. The concrete patches at the locations of the auxiliary (aux) steel piles are beginning to fail and exhibit isolated areas of spalling up to 1-inch deep. One (1) aux. pile location, at the east end of the pier near station 7+00, has a 1'-0" long x 4" wide x 2'-4" deep spall / void. The joint between the original and widened sections along the North Apron exhibits partially patched (with asphalt) voids approximately 1" wide x 1'-0" deep. The metal curbs are in serious condition overall and exhibit widespread paint failure with minor to moderate corrosion. At numerous locations the curb connection hardware is broken with the curb section loose. Along the South Apron curb, at the east end, there is a 40-foot-long section that is heaved approximately 1-foot high. The asphalt along the South Apron exhibits major wear, loose aggregate, 1/8-inch to 1/4-inch-wide cracking, and wear/abrasion. A sink hole along the South Apron has recently been filled with asphalt.

Photo 9: Typical transverse cracking in top of deck (North Apron shown)

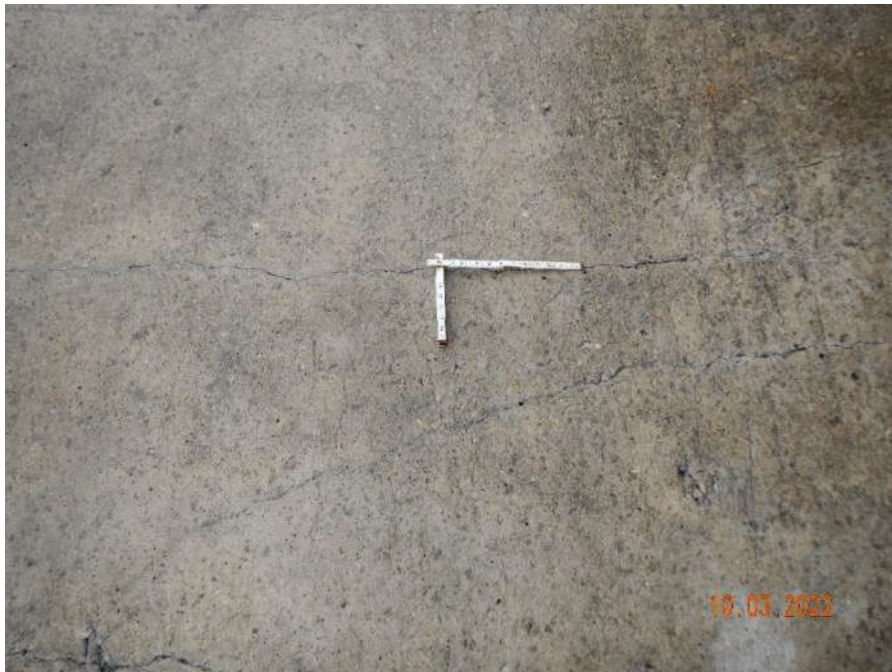
Photo 10: Typical transverse cracking in top of deck (North Apron shown)

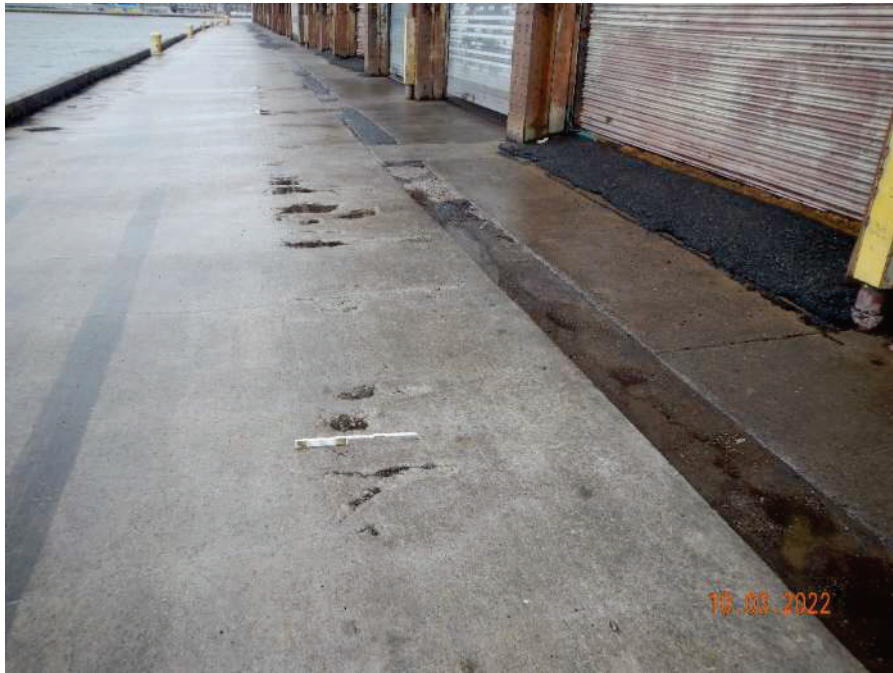
Photo 11: Typical shallow spalls in top of deck

- Broken and missing timber piles should be replaced with new steel piles.
- Steel curbs should be securely attached to the top of the deck or removed.
- Areas of severe spalling of the fascia or deck should be cleaned and patched.

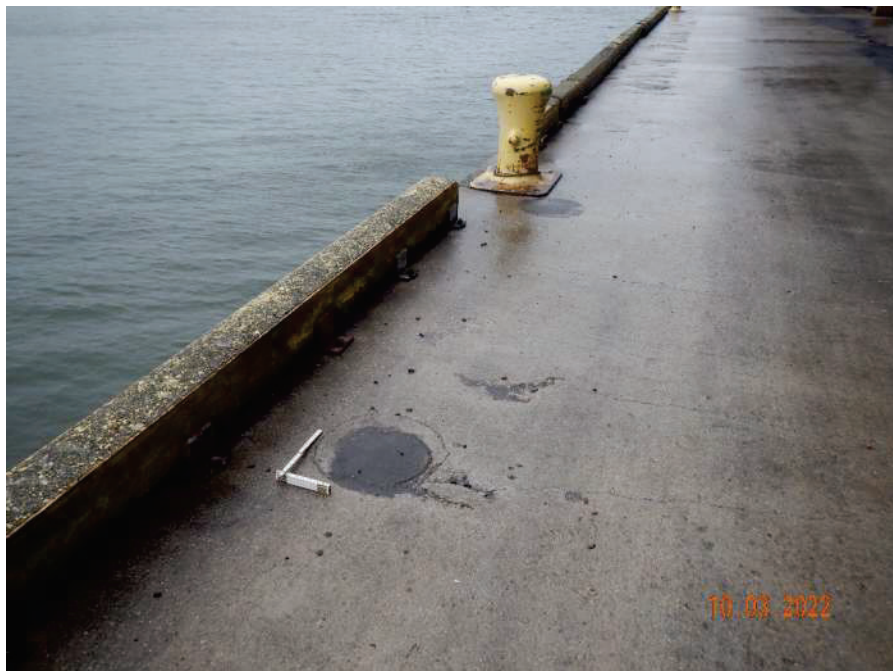
Photo 12: Typical Patch in top of deck for Aux. steel pipe pile

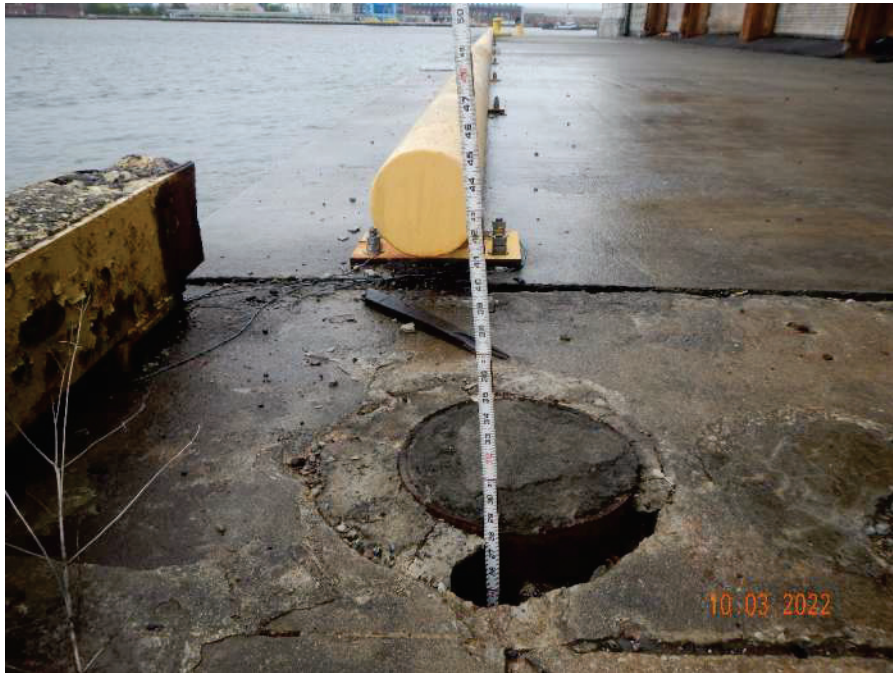
Photo 13: Isolated areas of spalling at Aux. steel pipe pile

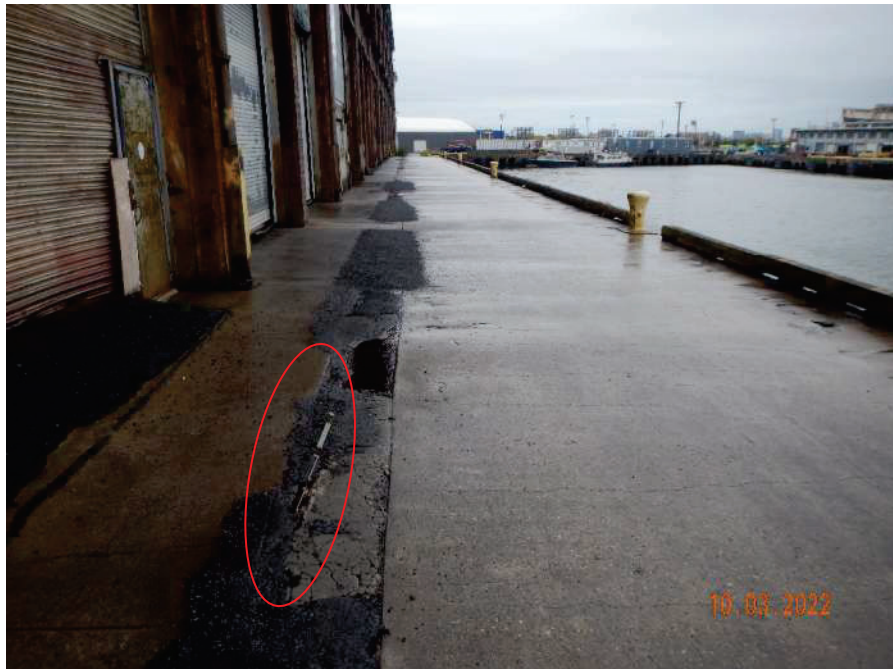
Photo 14: Area of separation between widened and original sections (North Apron shown)

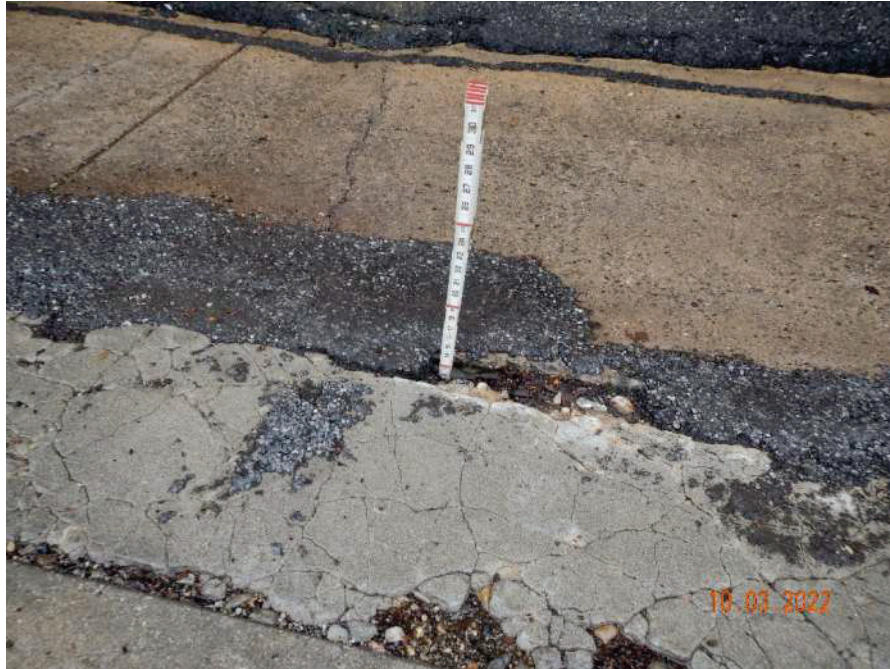
Photo 15: Area of separation between widened and original sections (North Apron shown)

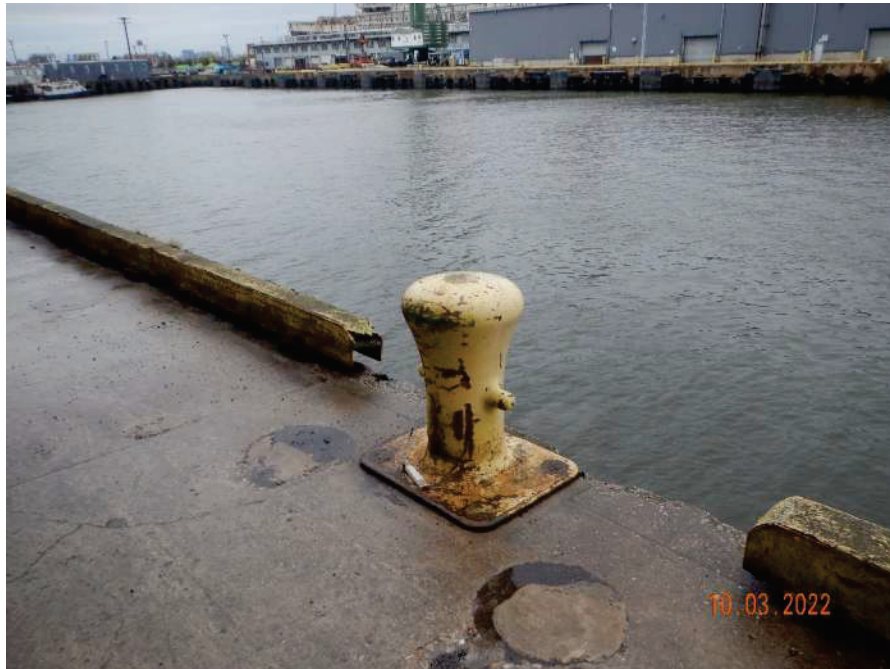
Photo 16: Typical failed curb (North Apron shown)

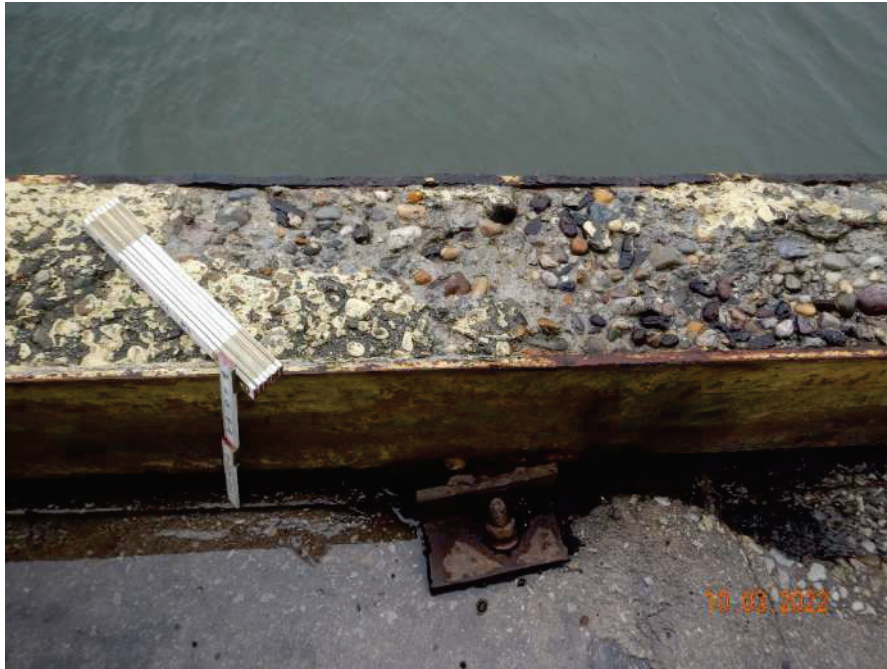
Photo 17: Typical failed curb connection (North Apron shown)

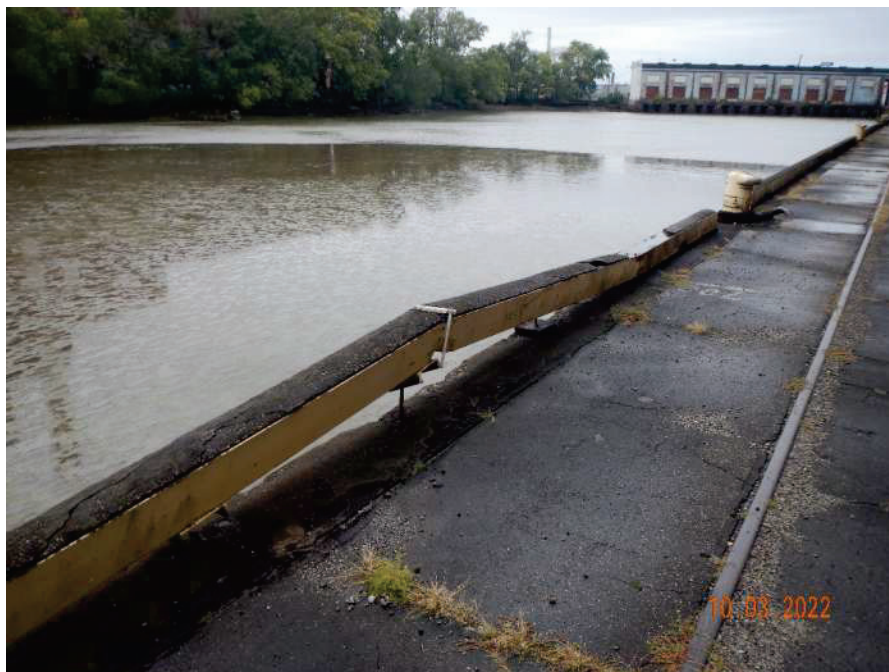
Photo 18: Typical failed curb (South Apron shown)

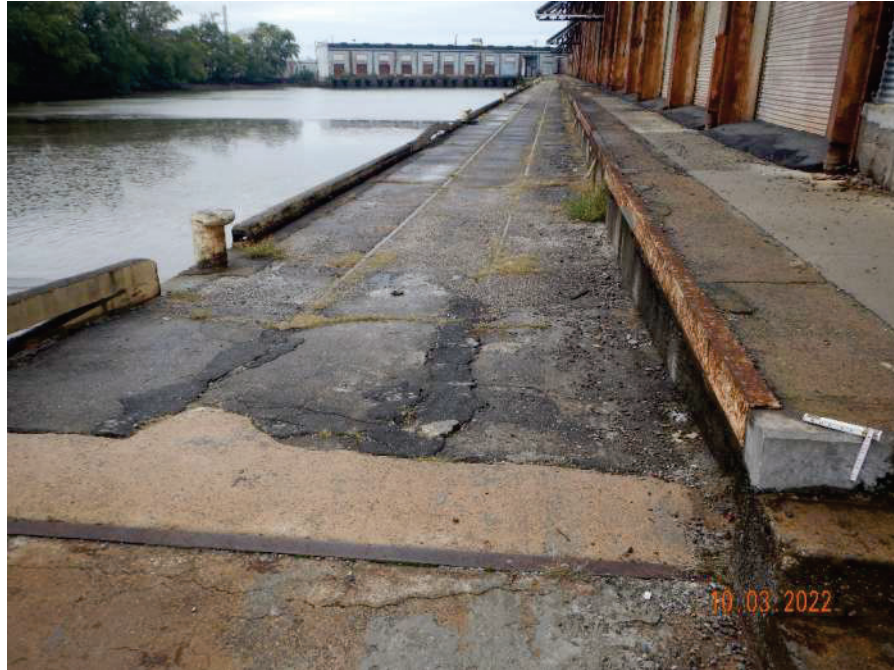
Photo 19: Typical failed asphalt along South Apron

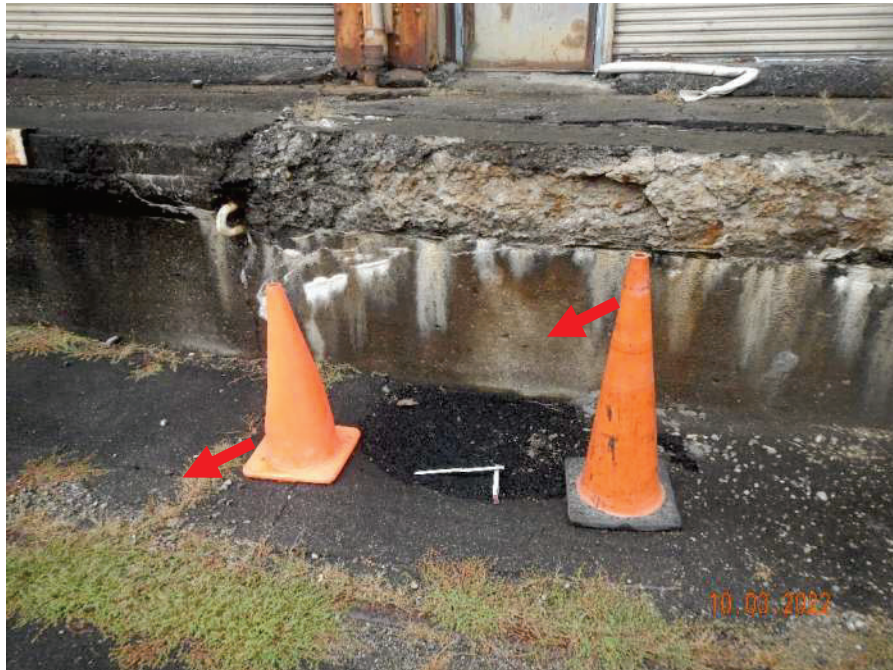
Photo 20: Recently patched sinkhole on South Apron

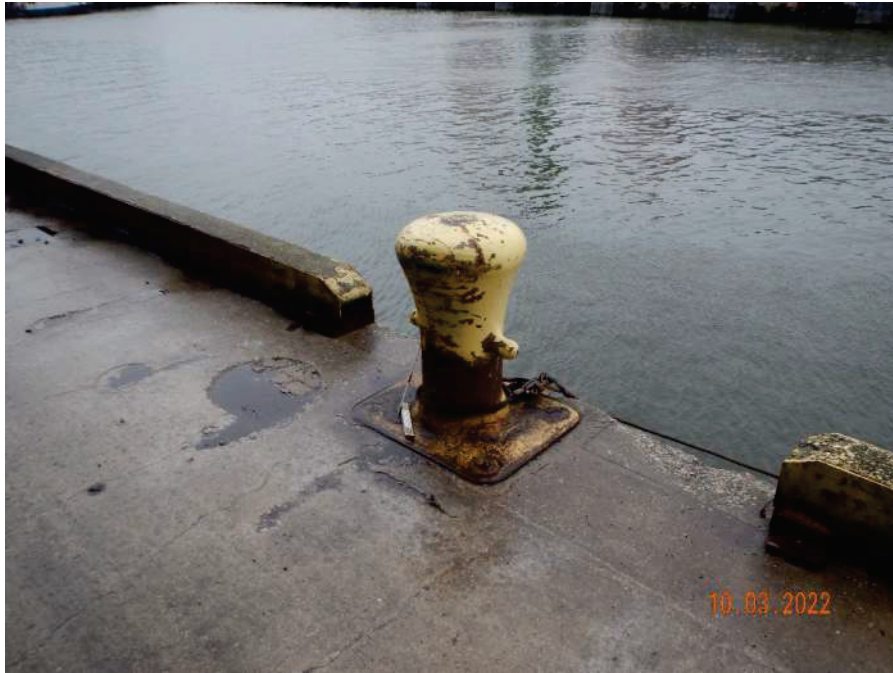
- 2.1.2 Bollards – Overall the Bollards were found to be in **Fair** condition. There are twelve (12) bollards along the north side, which exhibit varying degrees of deterioration that include typical paint failure and minor to moderate corrosion, with isolated locations of severe corrosion of the anchor bolts. There are eleven (11) bollards along the south berth. Due to the shallow water, limited access at low tide, and low likelihood of use, the bollards along the south side of the pier were not inspected or included in the overall rating of the bollards.

Photo 21: Typical bollard with minor to moderate corrosion

- Bollards with corrosion to the connection hardware should be replaced or protected from future corrosion. To better evaluate the conditions of the bollards and its hardware, WBCM suggests further testing by means of low strain ultrasonic testing to determine locations of stress fractures or loose anchorages that could reduce the bollard capacity. This test will provide the bollard's capacity based on its condition.

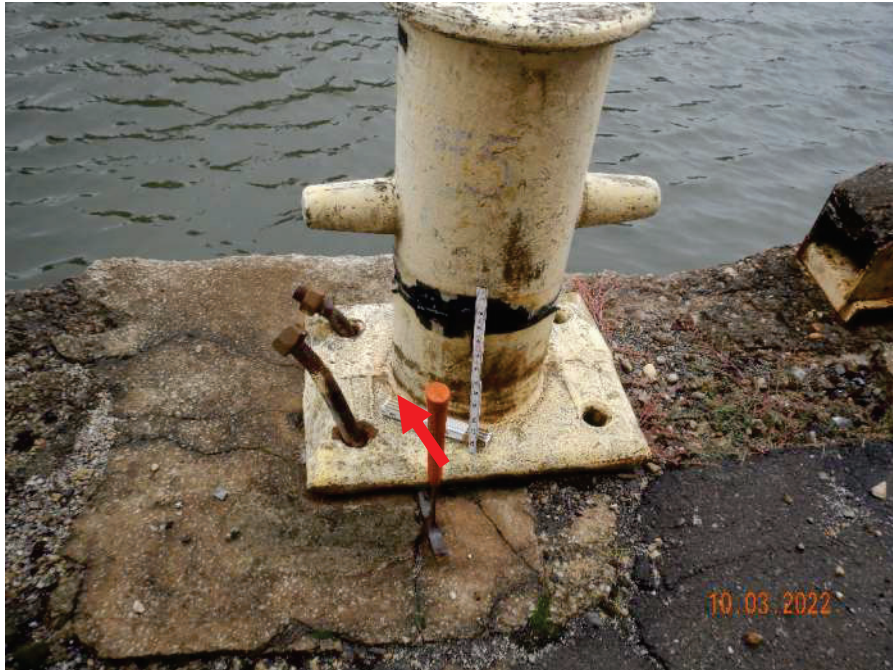
Photo 23: Failed bollard along the South Apron

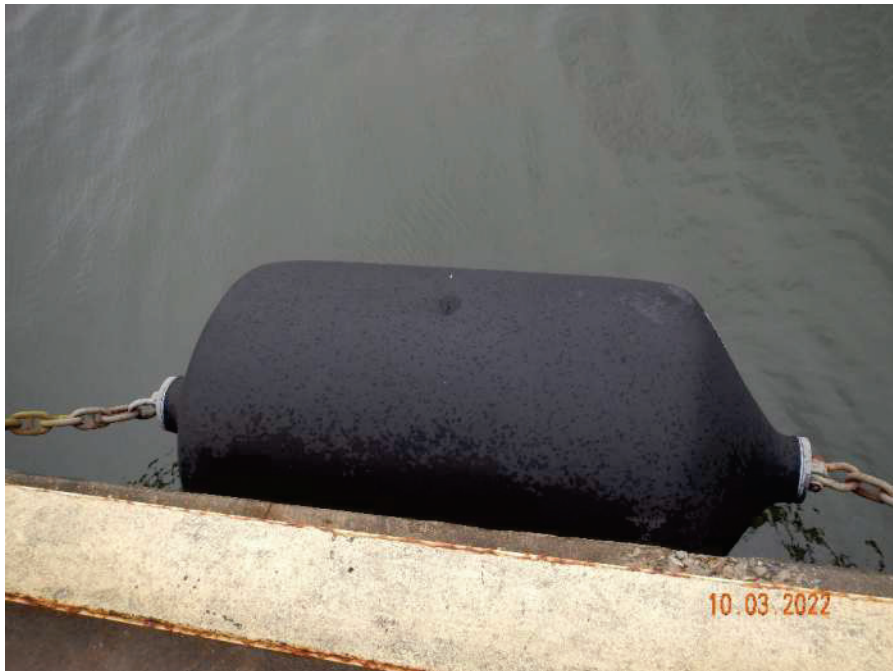
- 2.1.3 Fenders – Overall the Fenders were found to be in **Good** condition. There are a total of eleven (11) pneumatic fenders, one of which is backed by an H-pile grillage structure. The fenders typically exhibit light to moderate wear/abrasion throughout. There are remnants of tubular chain fenders along the south side of the pier, mostly loose and dangling from the pier within the tidal zone. Due to the shallow water, limited access at low tide, and low likelihood of use, the fenders along the south side of the pier were not inspected or included in the overall rating of the fenders.

Photo 24: Typical fender

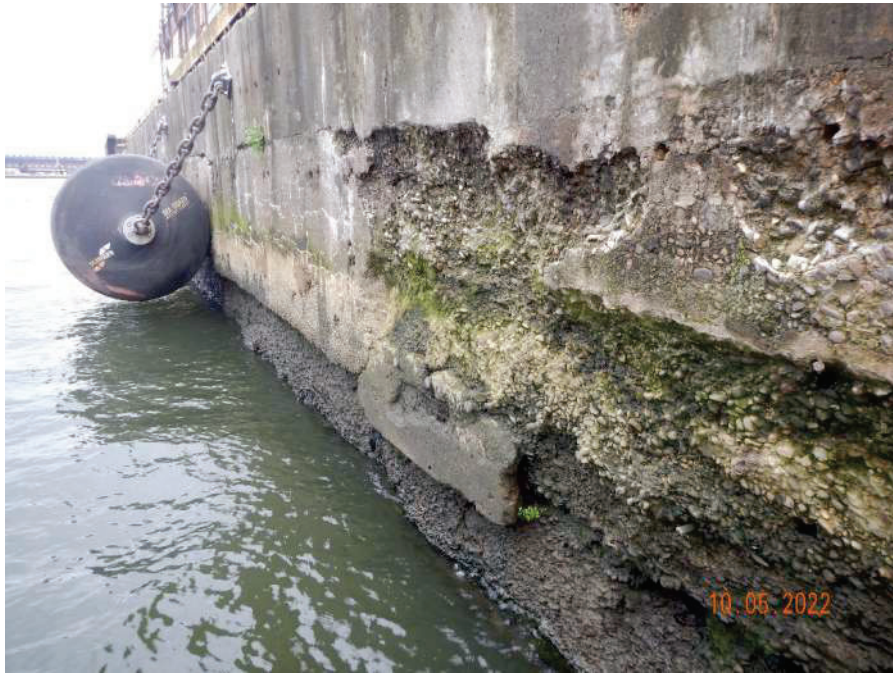
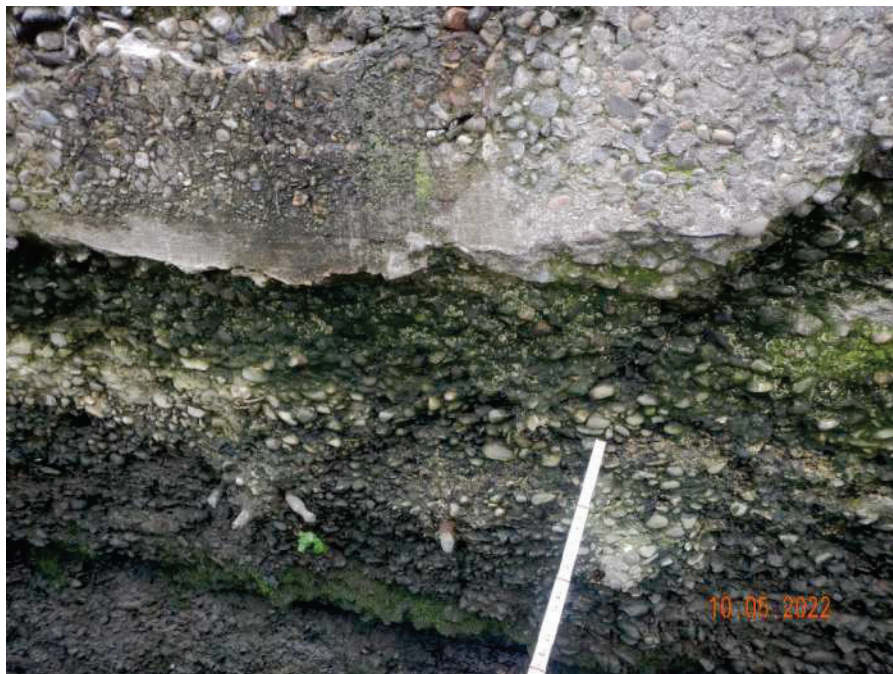
- 2.1.4 Deck Fascia – Overall the Deck Fascia was found to be in **Poor** condition. The concrete deck fascia exhibit widespread spalling up to 6-inches deep with exposed steel reinforcement throughout the fascia for the bottom 3-feet near the waterline.

Photo 25: Typical spalling along deck fascia

Photo 26: Typical spalling along deck fascia

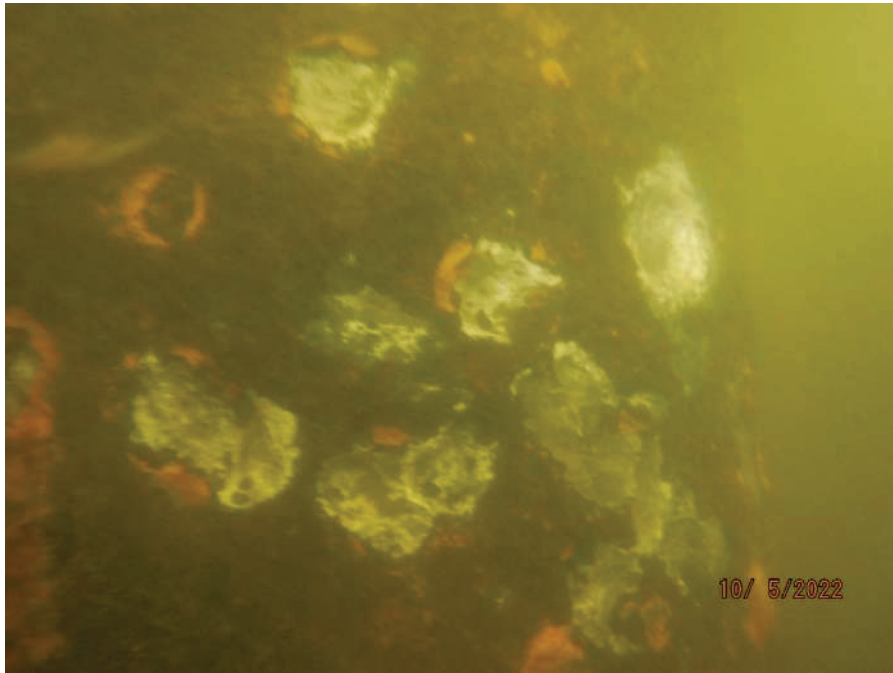
All the steel pipe piles were found to have major defects. These piles are typically uncoated and exhibit moderate corrosion with up to ¼-inch-deep pitting throughout. Microbial influenced corrosion was observed at the steel pipe piles.

Photo 27: Typical microbial influenced corrosion at steel Aux. piles

- Steel auxiliary piles should be protected from further corrosion with use of fiberglass jackets or wraps, or a cathodic protection system. If a cathodic protection system is utilized, care should be taken to prevent the microbial corrosion as studies have shown that cathodic potentials do not have an effect on the attachment and viability of sulfate reducing bacteria (microbes that cause corrosion).

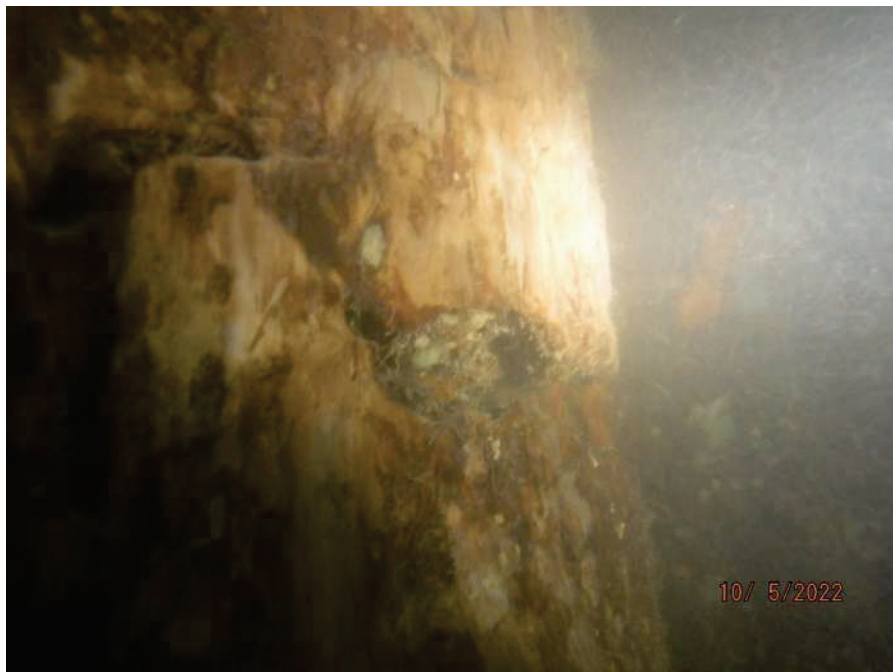
The timber piles typically exhibit minor checks and shakes throughout. 26% (144 Piles) of the timber piles inspected were broken or missing at the cap. It appears that the broken/missing piles were fractured due to impact from ship berthing or dredging operations. There is evidence on the broken piles of vertical scrape marks on the exterior faces, that appear to be from a dredging bucket. The timber piles typically have good bearing at the cap and shoulders.

Photo 30: Typical broken timber pile
